# Tracing seismic surface waves induced by road traffic in urban environment: example of st. Catherine's church hill in Warsaw

Tucholka P., Kielbasiński K., Mieszkowski R. Tracing seismic surface waves induced by road traffic in urban environment: example of St. Catherine's church hill in Warsaw. *Geologija*. Vilnius. 2008. Vol. 50. Supplement. P. S79–S84. ISSN 1392-110X

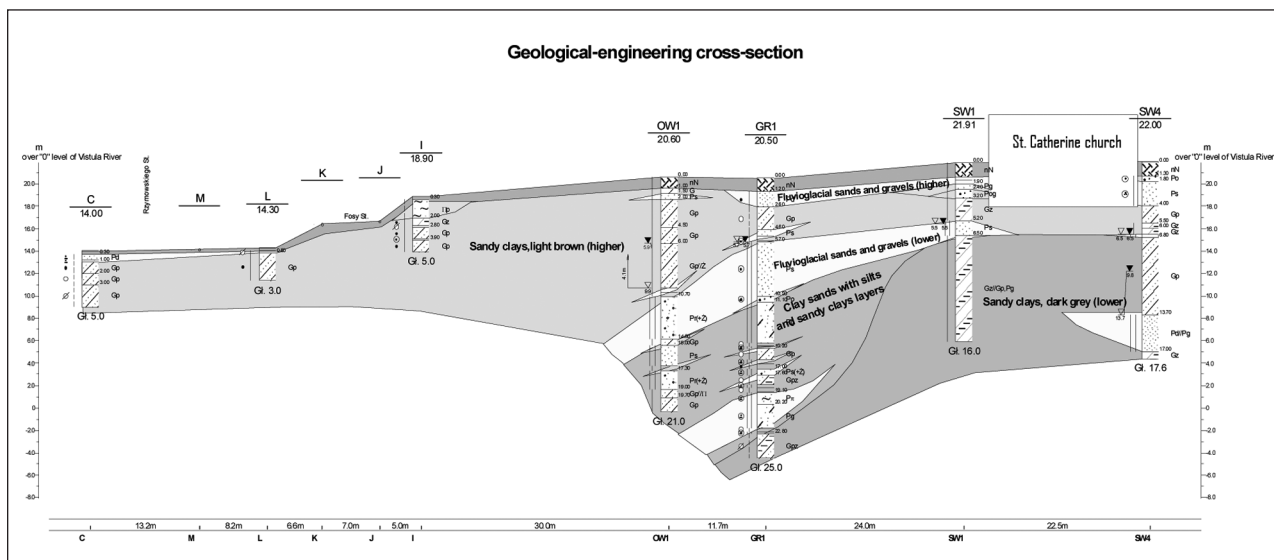
The hill is mostly built of sandy loams or clayish sands (Fig. 1) in a semi-consistent to firm state. These sediments are strongly consolidated, with a tendency to horizontal fracturing. The appearing fractures break the sediment into irregular horizontal layers not exceeding 5 cm in thickness. Under these clays appear fluvioglacial sands, in part saturated with water. Just under the surface, a large proportion of soil consists of anthropogenic rubble.

Fig. 1. Geological-engineering cross-section through the southern part of St. Catherine church hill

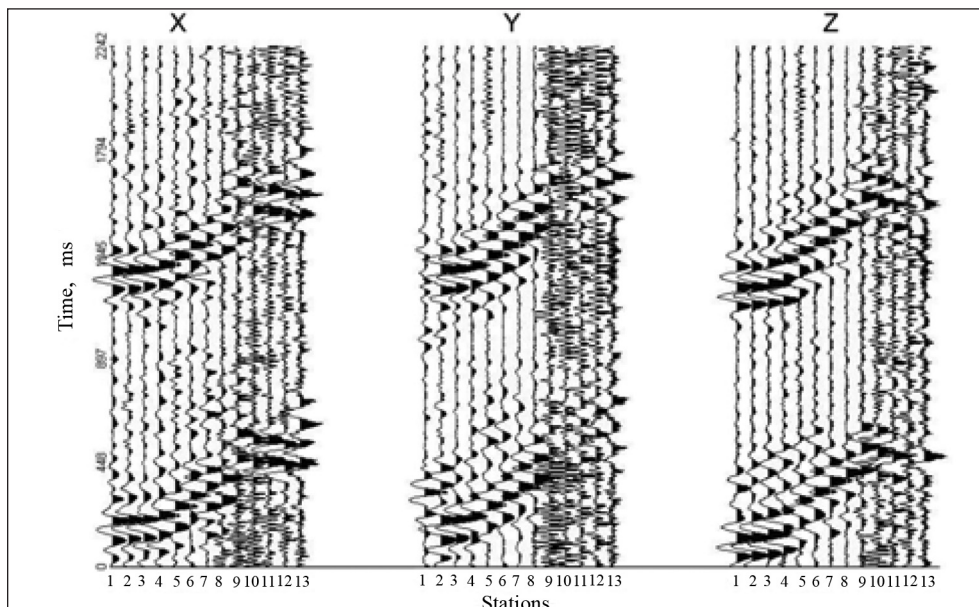
vehicle was spotted on the street. Thirty five such batches were recorded. An example of record is given in Fig. 4. It is clear that the passage of a vehicle corresponds to a vibration wave distinctly identifiable in the first eight stations positioned between the street and the church, less clearly pronounced in the four stations along the church, and again visible on the record of the last station on the wall of the church. Moreover, records of the wave allow identifying two wave bursts produced by the passage of the front and rear axles of the vehicle with the time gap of about 1 second.

Fig. 4. Seismic signal recorded when a heavy vehicle runs along the road

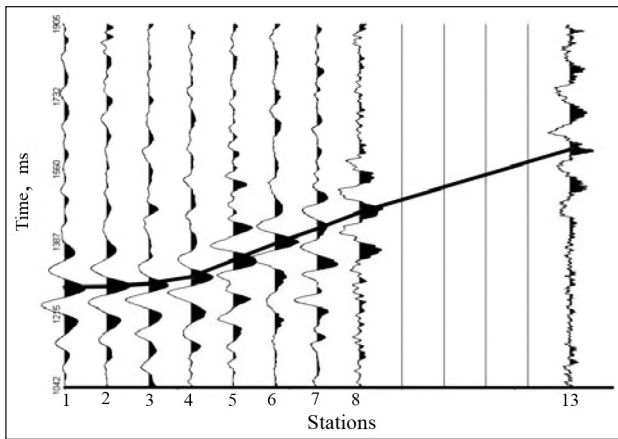
An example of a record is given in Fig. 4. To obtain the velocity, the cross-correlation was used to calculate the shift of the phase between the records. This corresponds to, e. g., a clearly visible phase shift as shown in Fig. 5 for the first eight stations along the profile and on the record from the church wall. Records from the stations 9–13 show a high noise and were not interpreted in this preliminary analysis.

Fig. 5. (Subset of Fig. 4). Fragment of record for component X. The third maximum of the wave was picked to calculate the velocity. Records for Stations 9–12 along the church wall were muted

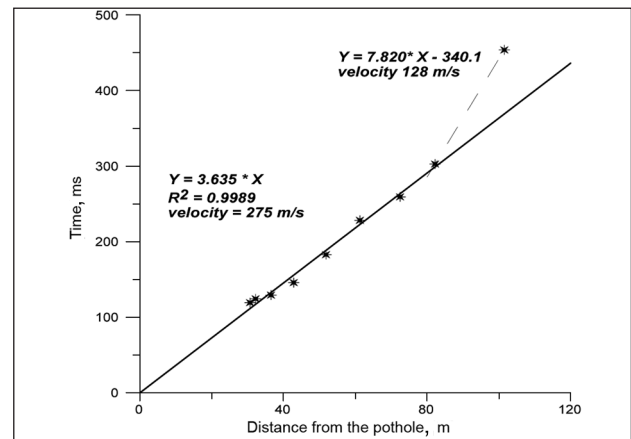
The pattern of time arrivals shows two different velocities: 275 m/s corresponding to the first eight stations lying on the slope between the street and the inner terrace wall, and a much lower 128 m/s velocity for the segment close to the church. This deceleration of wave propagation may be explained by the rubble material around the church.

Fig. 6. Time of arrival vs. distance for the wave burst from Fig. 5. Regression lines are for the first eight stations and for the passage from Station 8 to the church wall

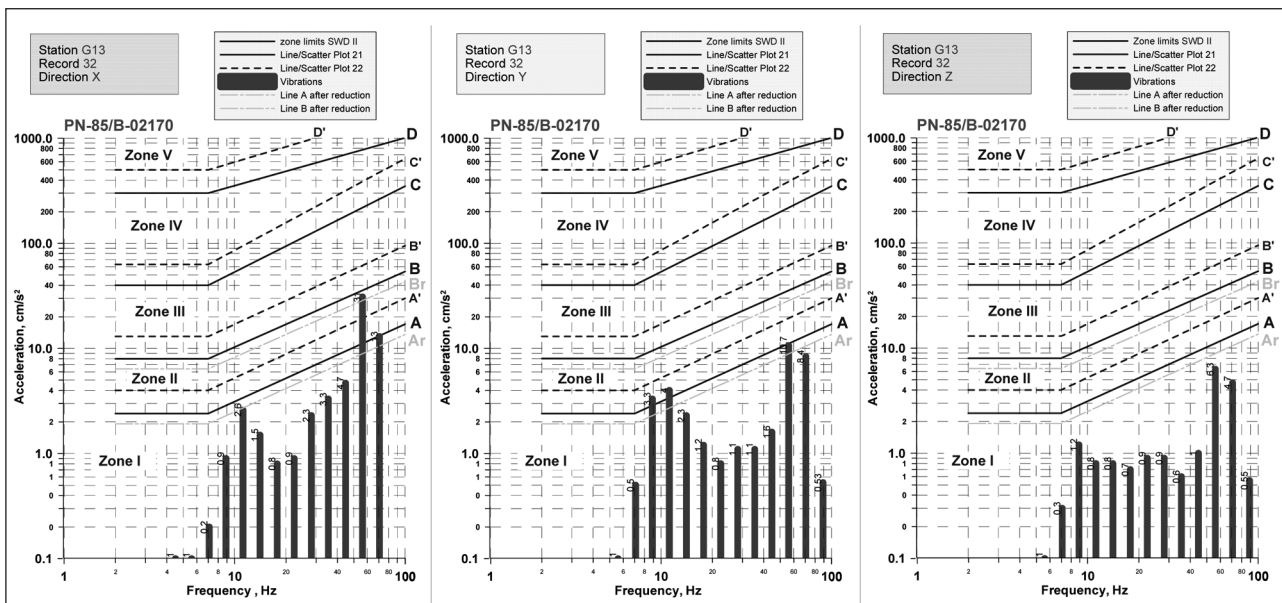
Fig. 7. Acceleration of vibrations recorded on the church wall in three (X, Y, Z) components on the scale of potential damage introduced in the norm (PN-85/B02170)

The norm (WATTS, 1988) determines the potential damage of vibrations in frequency bands in categories specifying the degree of risk on a scale rising from minor or negligible (Zone I), through not dangerous to the construction, but potentially damaging to frescos and mortar (Zone II) up to a total destruction of the structure in zone V. For large, old buildings, the norm has obviously limits of the zones lowered to provide for ancient and possibly altered building materials and nonstandard construction techniques. In Fig. 7, one can see that the recorded vibrations exceeded in several cases the lower limit of Zone II, both for lower and higher frequency bands in horizontal components X and Y, and for the high frequency vibrations in the Y component they clearly exceeded the lower limit of Zone III (vibrations harmful to the building construction inducing fractures and breaks).

The results from 1997 (Ciesielski et al., 1997) are shown in Fig. 8. The major difference between these results and the results of this work is the different frequency range of the spectra. The 1997 results cover the frequencies from 2 to 16 Hz, while our data cover the range from 10 to 100 Hz. A slight comparable increase of intensity is observed in our data (Fig. 7) in the range 10–16 Hz.

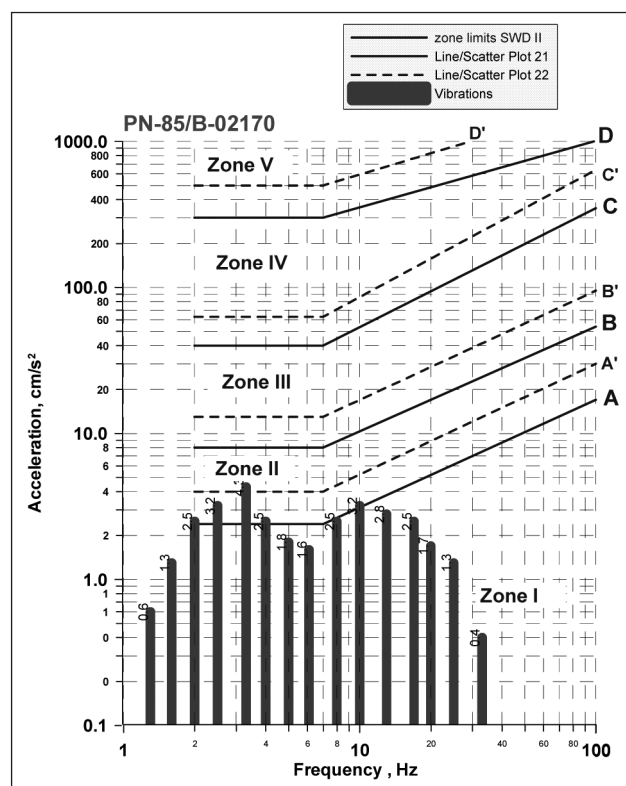
Fig. 8. Results of investigations executed in 1997 under direction of R. Ciesielski (Ciesielski et al., 1997)
