Morphodynamics of the River Łososina Channel after an extreme flood (Western Carpathian Mountains)

Gorczyca E. Morphodynamics of the River Łososina channel after an extreme flood (Western Carpathian Mountains). *Geografija*. 2007. T. 43. No. 2. ISSN 1392–1096.

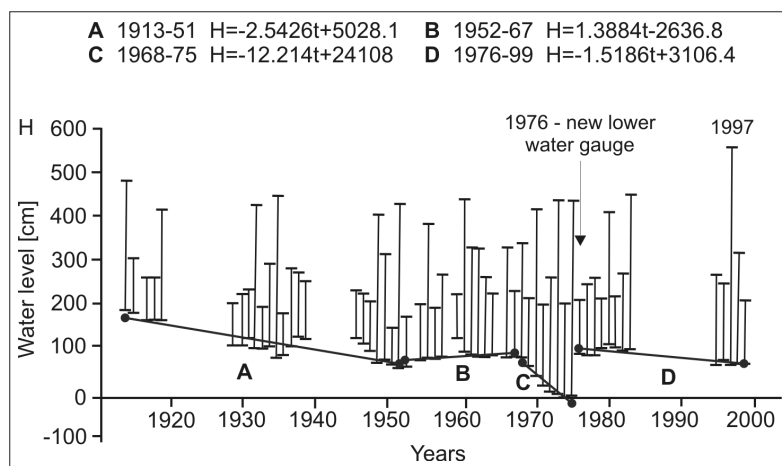
Fig. 3. Minimum and maximum water levels on the river Łososina during the period 1913–2000 at Jakubkowice (Fig. 1B)
3 pav. Lososinos upės minimalių ir maksimalių vandens lygių kaita Jakubkovičių vandens matavimo poste 1913–2000 m. (1 pav., B)

(Fig. 3). During the following period – 1952–1967 – minimum water levels increased by 1.3 cm pa and the channel bottom rose by 35 cm overall. The period 1968–1975 was marked by an intensive downcutting, resulting in an 82 cm deepening of the channel. This trend continued subsequently, increasing the channel depth by another 20 cm in 1976–1999 to reach an overall deepening of 202 cm during the period 1913–1999 (Fig. 3). The average discharge during that period was 2.58 m³/s at

A long-term minimum water level analysis provides clues as to whether the channel bottom is rising or deepening (Fig. 3). A comparison of these parameters at the two hydrometric transects clearly shows that the channel is deepening in the lower course of the river (Jakubkowice). During the period 1968–1975, at Jakubkowice the channel bottom was deepening at the rate of c. 11 cm/year and during the period 1976–1999 c. 1.5 cm/year. A reverse trend was observed in the late 1990s when the channel bottom at Piekiełko was rising by 2.8 cm per year (Sołtys, 2001).

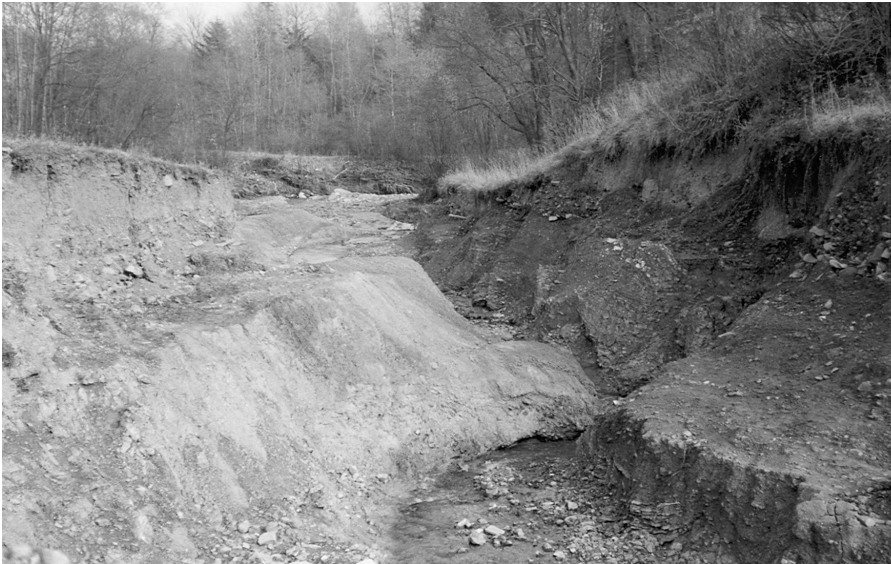
Fig. 4. New avulsive channel of the Starowiejski stream cut down to c. 2 metres in solid ground during the 1997 flood

Numerous cutbanks evolved and there were some cases of avulsion of the main and tributary channels (Fig. 4). A mass of angular-edged material was supplied into the channels from various types of landslumps and cutbanks (Fig. 5). In the middle and lower sections of the Łososina basin the mapping exercise yielded 505 landslide forms, primarily minor landslumps (Gorczyca 2004). Between Tymbark and the river mouth 101 landslide forms emerged, mostly small landslumps, but also some larger landslides. An effort was made to assess the quantity of material supplied to the channel system from these features. From the mapped surface area of the landslide features and their depth, the figure was estimated at c. 820,000 m³. This, however,

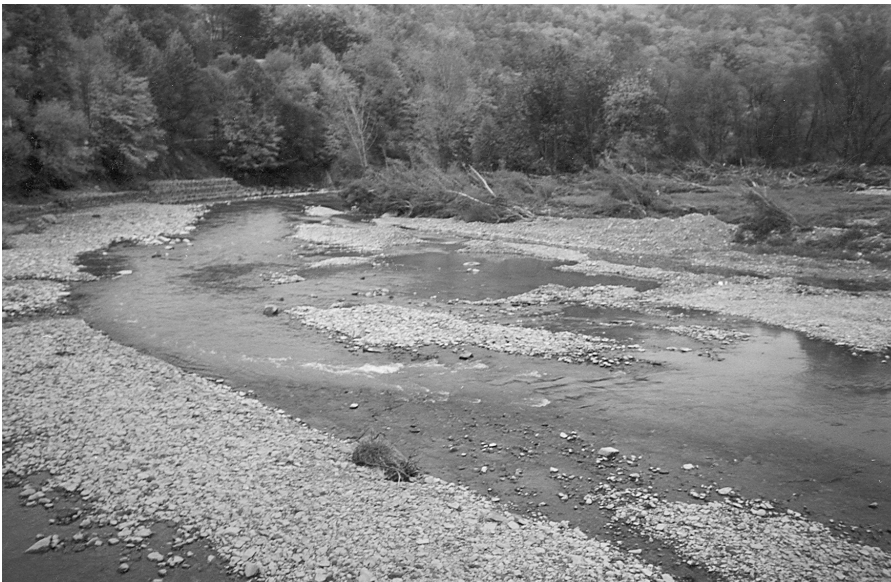
Fig. 5. A zone with clearly marked accumulation across the Łososina channel width after the 1997 flood

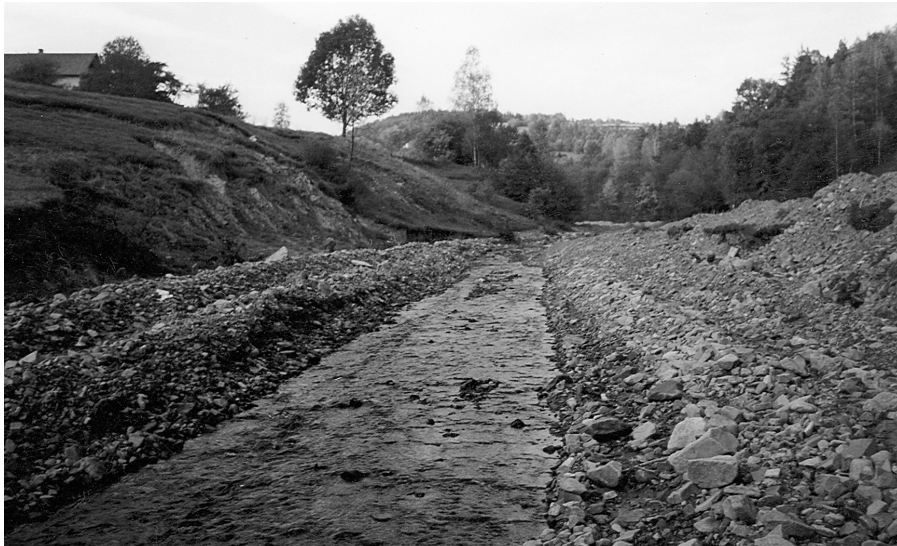
Fig. 6. The Kamionka stream channel after the 1997 flood
